KANSAS DEPARTMENT OF HEALTH AND ENVIRONMENT
BUREAU OF ENVIRONMENTAL REMEDIATION
M E M O R A N D U M

TO: Larry Knoche
FROM: Rachel Miller *RM*
DATE: October 12, 1992
SUBJECT: Mid-America Refinery (MARCO), Chanute
=====

MARCO SITE VISIT REPORT
October 9, 1992

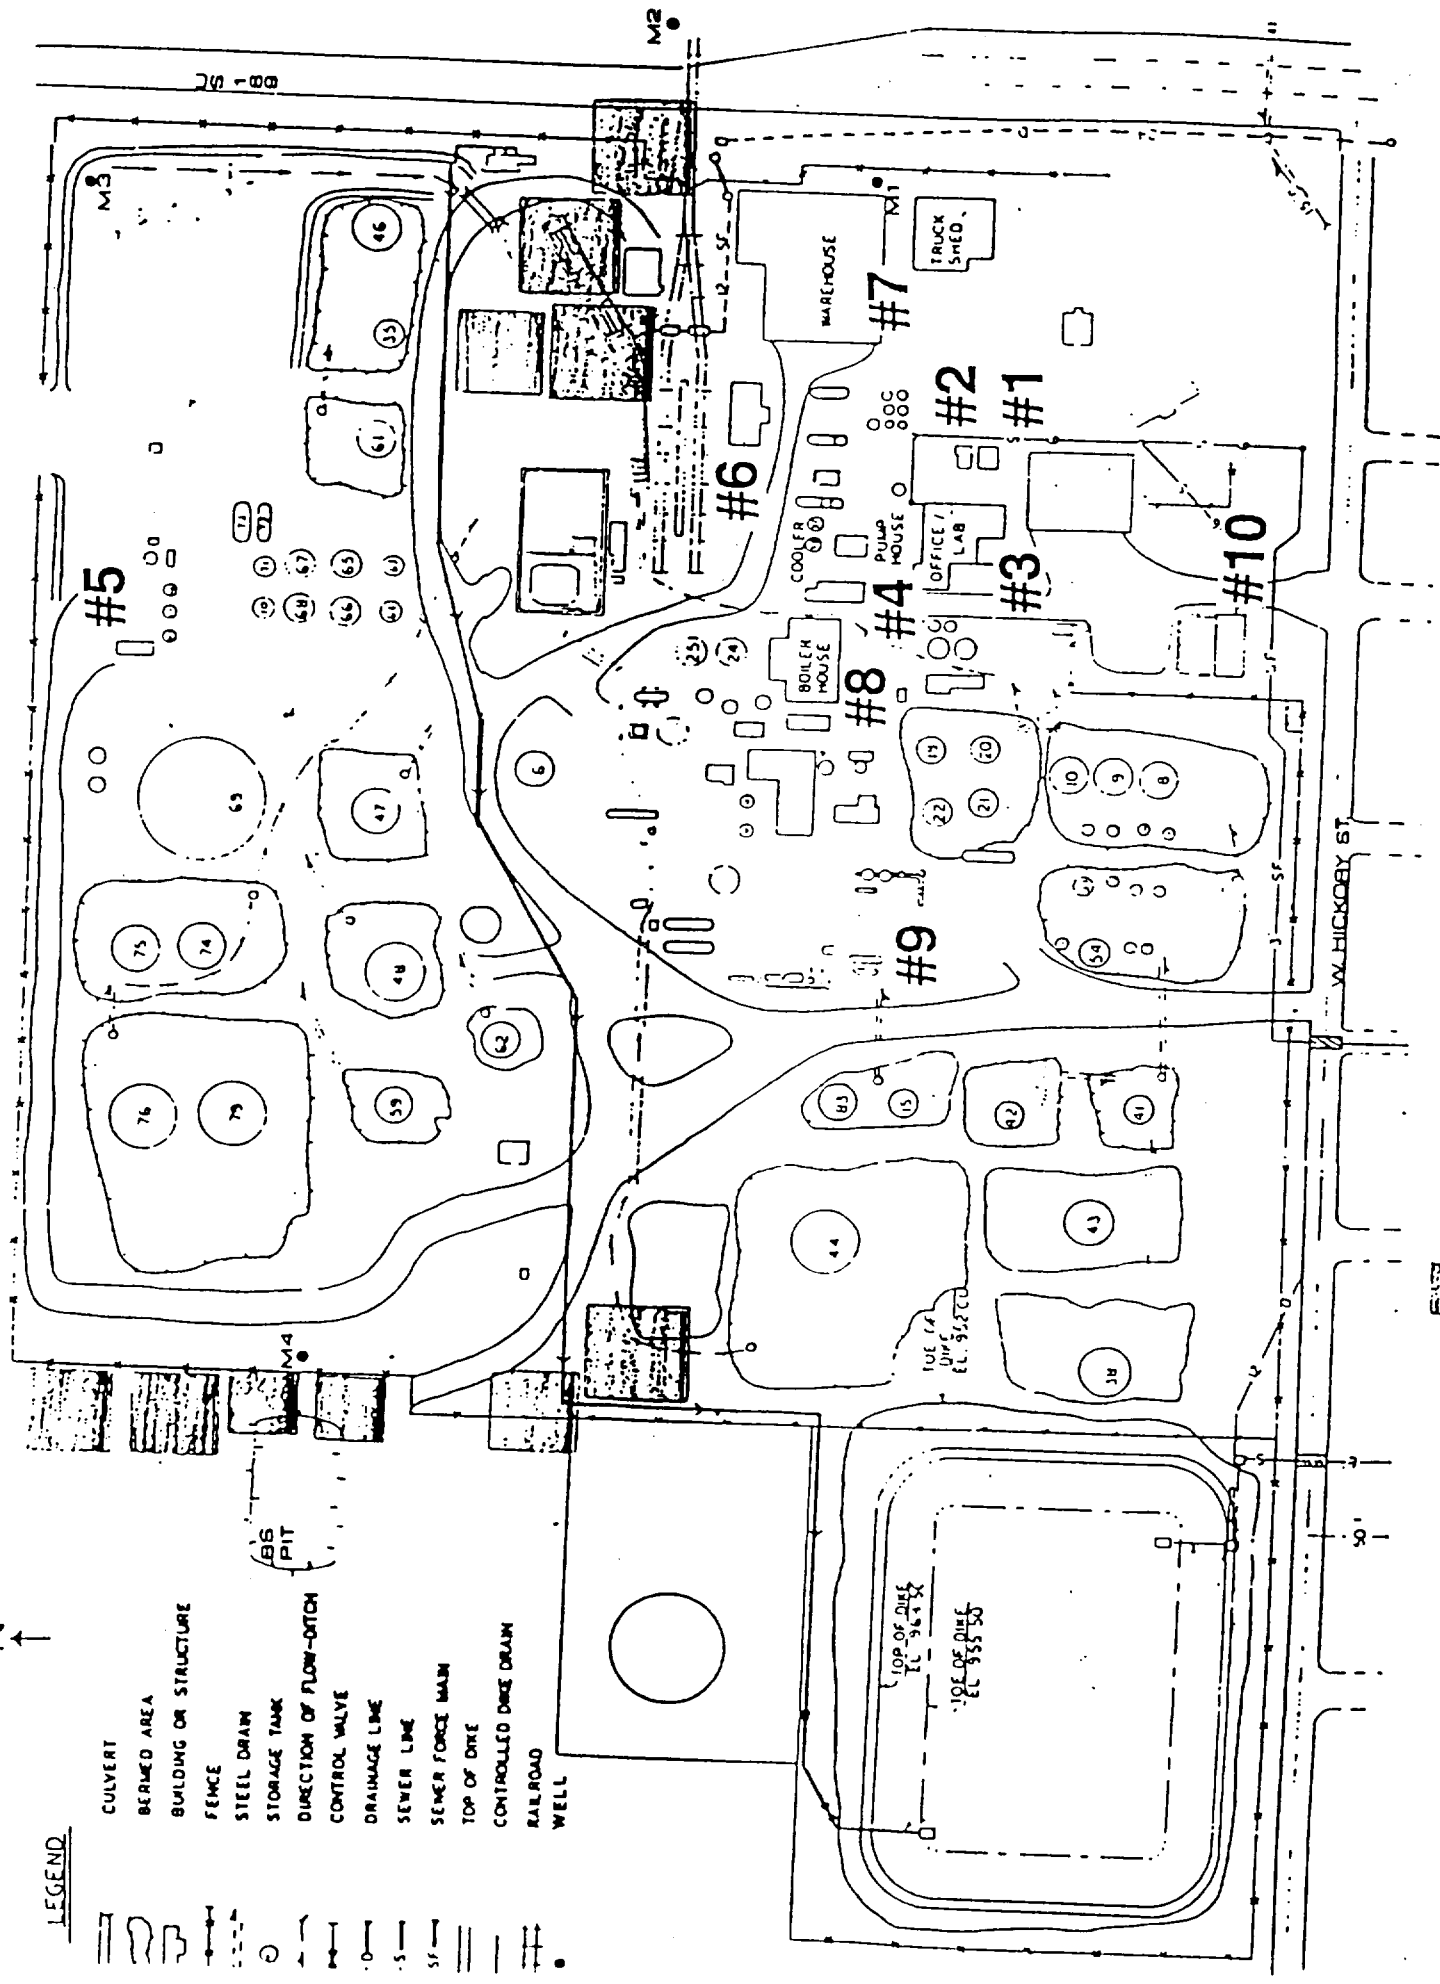
* Buildings and areas referred to in this report are marked on the attached map

#1 - Small building next to lab on southeast side. Many bottles and chemical containers are present in the building; there is an oily substance on the floor and on a mop on floor; 1 file cabinet with papers and files is present; there is much broken and unbroken chemistry glass; the following marked and unmarked containers are present:

#2 Small building to the north of #1. The upstairs room contains many pint glass bottles of a brownish liquid (product?) marked with eroded paper labels and numbers; there are many rusted cans with no lids. The downstairs room is very "messy"; 5 gal. bottle of carbon tetrachloride, paint thinner can, and many rusted 1 gal. cans are present.

#3 Main lab building. 1st room: sink full of black water/oil; the roof is leaking badly; there are many computer disks on the floor; the following marked and unmarked containers are present:

#6 Building. odor present inside; many drums- some marked acetic acid; rusted drum with red powder substance spilling out; 30 gal.? glass bottle with wood protection; 5 gal. bottle on high shelf appears to have exploded- black tarry substance in pieces of it; drum with oil/bronze liquid; 23 drums appear full or partly full- some marked: rust inhibitor, santoluene; 2 boxes with unknown bottles of chemicals;

#7 Warehouse building. Roof is decaying; some beams and floorboards from the upper level have collapsed; a few drums, and asbestos material? are present on lower level; thousands of quart oil cans are present upstairs along with a few drums;

#8 Main boiler room. drums present in back area of room; broken glassware; plastic/fiberglass container with some white precipitate; damaged bags of epoxy type material; oily area oosing into west wall of room; standing oil around outside of a building just west of boiler room;

#10 Office building. contains a safe, an open refrigerator, many files and papers, a desk, spot remover, cleaners, duplicating fluid; the roof is leaking badly- carpet is soaked with water;
